# Manhole Inspection Summary

Manhole # S29K\_\_069MH

Insp Date: **2/2/09 12:59 PM**

**Location** Address: **401 S.Fremont Ave.**

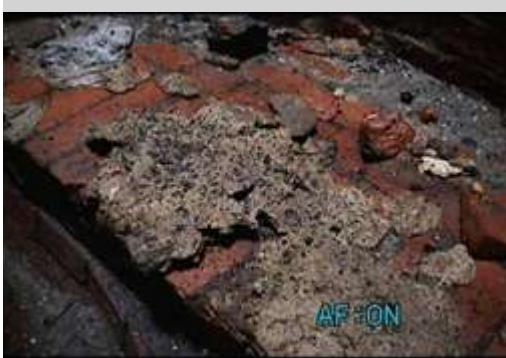
Miscellaneous

debris on bench

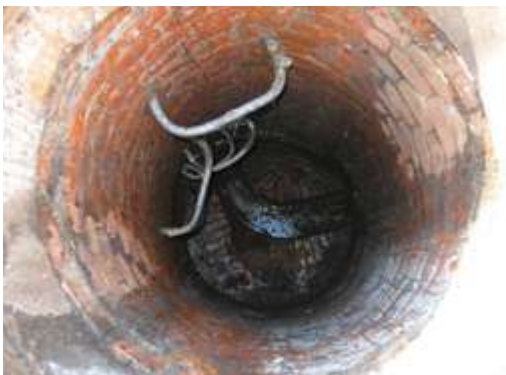
Defect 2

Condition: ☐ Sound ☒ **Cracked** ☐ Root Intrusion ☒ **Loose Brick** ☐ Deteriorated

Infiltration: ☐ None ☐ Joint ☐ Cracks ☐ Mortar ☐ Roots ☒ **Wall**

chimney and corbel infiltration  
chimney cracked

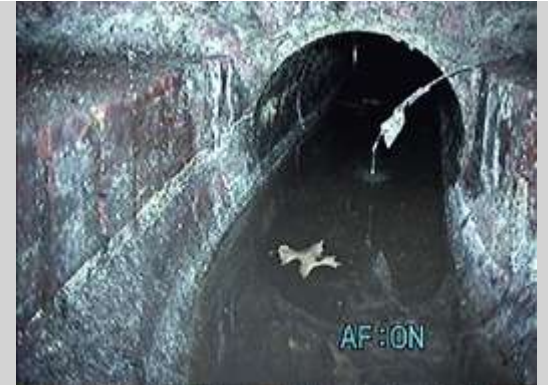
12 O'Clock Outflow

10 in. Circular Gravity Sewer  
Pipe Out @ 12 O'Clock

Pipe Height: **10.8** (in.) Rod and Bar (Angled)  
Pipe Material: **Clay** ☐ Pipe Lined  
Invert Depth: **12.05** (ft.) Flow Characteristics: **None**  
Deposits: ☒ None ☐ Mud ☐ Sludge ☐ Debris ☐ Grease  
Silt Depth: **0** (in.) Deposits Extent:  
Infiltration: **None** Pipe Seal Cond: **Sound**

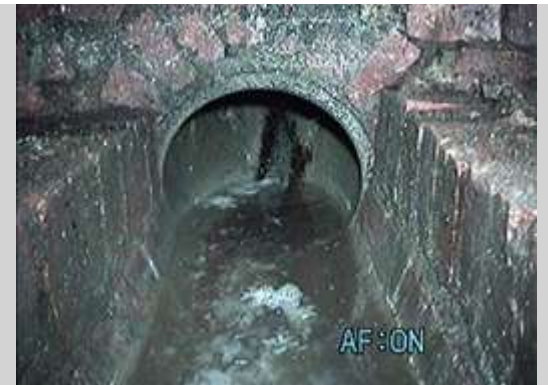
3 O'Clock Inflow

10 in. Circular Gravity Sewer  
Drop In @ 3 O'Clock

Pipe Height: **10.8** (in.) Rod and Bar (Angled)  
Pipe Material: **Clay** ☐ Pipe Lined  
Invert Depth: **9.78** (ft.) Flow Characteristics: **None**  
Deposits: ☒ None ☐ Mud ☐ Sludge ☐ Debris ☐ Grease  
Silt Depth: **0** (in.) Deposits Extent:  
Infiltration: **None** Pipe Seal Cond: **Sound**

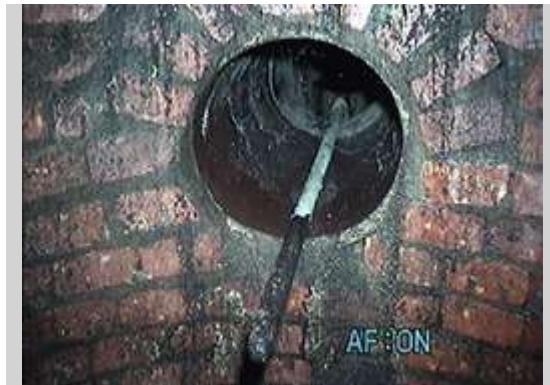
Drop: **Outside** Rod and Bar  
Angled: **Yes** Reading: **10.99** (ft.)  
Inv Depth: **11.99** (ft.)  
Drop Condition: **Open**
